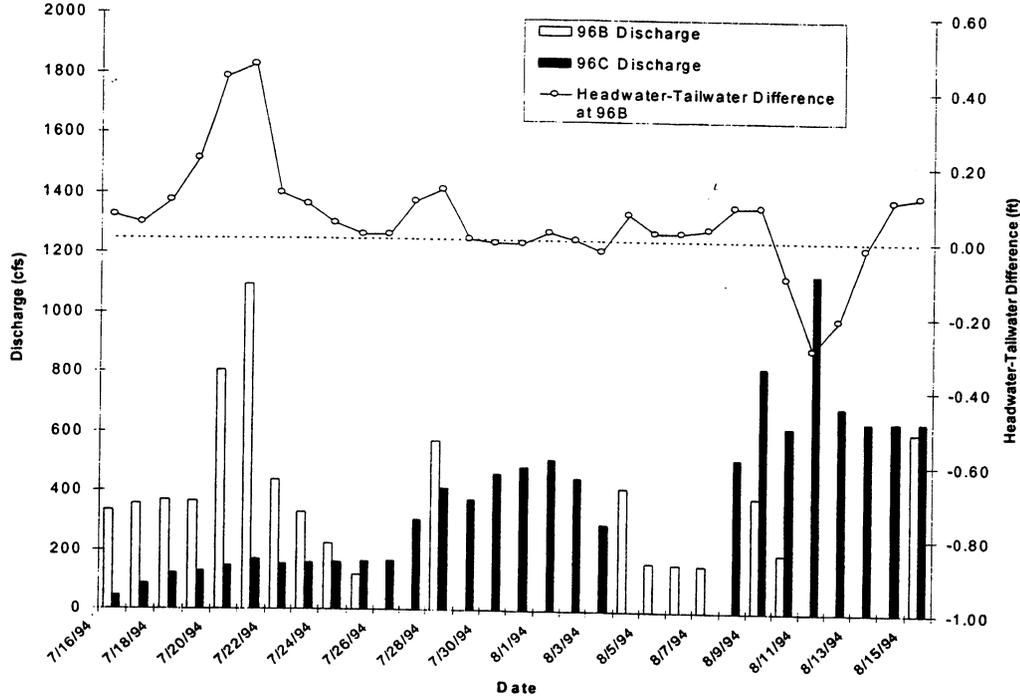
Figure 4. Discharges from structures S-96B and S-96C during July – August 1994 versus the headwater-tailwater difference at S-96B. Upstream water levels exceeded flood control regulation schedules at both structures. When the headwater-tailwater difference at S-96B is negative, such as occurred on August 12, conditions exist for reverse flow at S-96B and flood control discharges through this structure cannot be made. Consequently, because of this tailwater effect, discharges have to be staggered between S-96B and S-96 to maintain upstream flood control levels.
