Bayport Channel Seagrass Baseline and Monitoring Event Information

**HERNANDO COUNTY PORT AUTHORITY
BAYPORT CHANNEL
SEAGRASS MONITORING PROJECT
DEP Permit No. 271422133**

Baseline Report

**BERRYMAN & HENIGAR
Division of Environmental Services
640 East Highway 44
Crystal River, Florida 34429
(904) 795-6551
Job No. 55685.00**

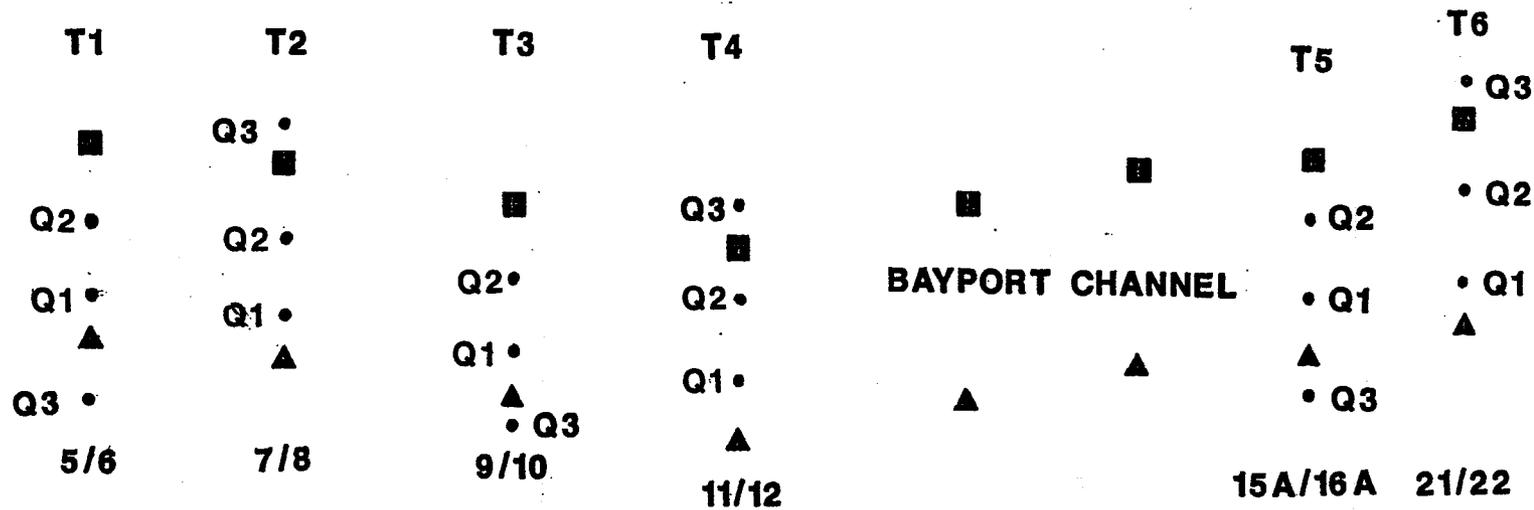
FIGURE 2

5/6 = CHANNEL MARKER GROUP

▲, ■ = CHANNEL MARKER LOCATION

T1 = TRANSECT #1

Q1 = QUADRAT #1

CHANNEL TRANSECTS

This report provides the results of the first formal (baseline) seagrass monitoring event conducted at the Bayport Channel, maintained by the Hernando County Port Authority. The project site is located in Section 25 and 36, Township 22 South, Range 16 East, Hernando County, Florida, at the western terminus of CR 550/SR50 (Figure 1). The DEP permit is for a channel maintenance dredging project. The permit conditions specified that permanent sampling stations be established at six groups of channel markers within the existing Bayport Channel. A general channel area map with channel marker and established quadrat locations is presented in Figure 2.

Photo-stations are situated underwater along the east side of each quadrat with the bottom of each picture being the east side of the quadrat. Eighteen photographs are taken with the 1m² sampling quad in place. The locations of photo-stations are provided in Figure 2.

Photodocumentation of the site taken during this monitoring event is provided in Photo-Figures 1 through 18, attached. Photo-station locations are shown in Figure 2.
