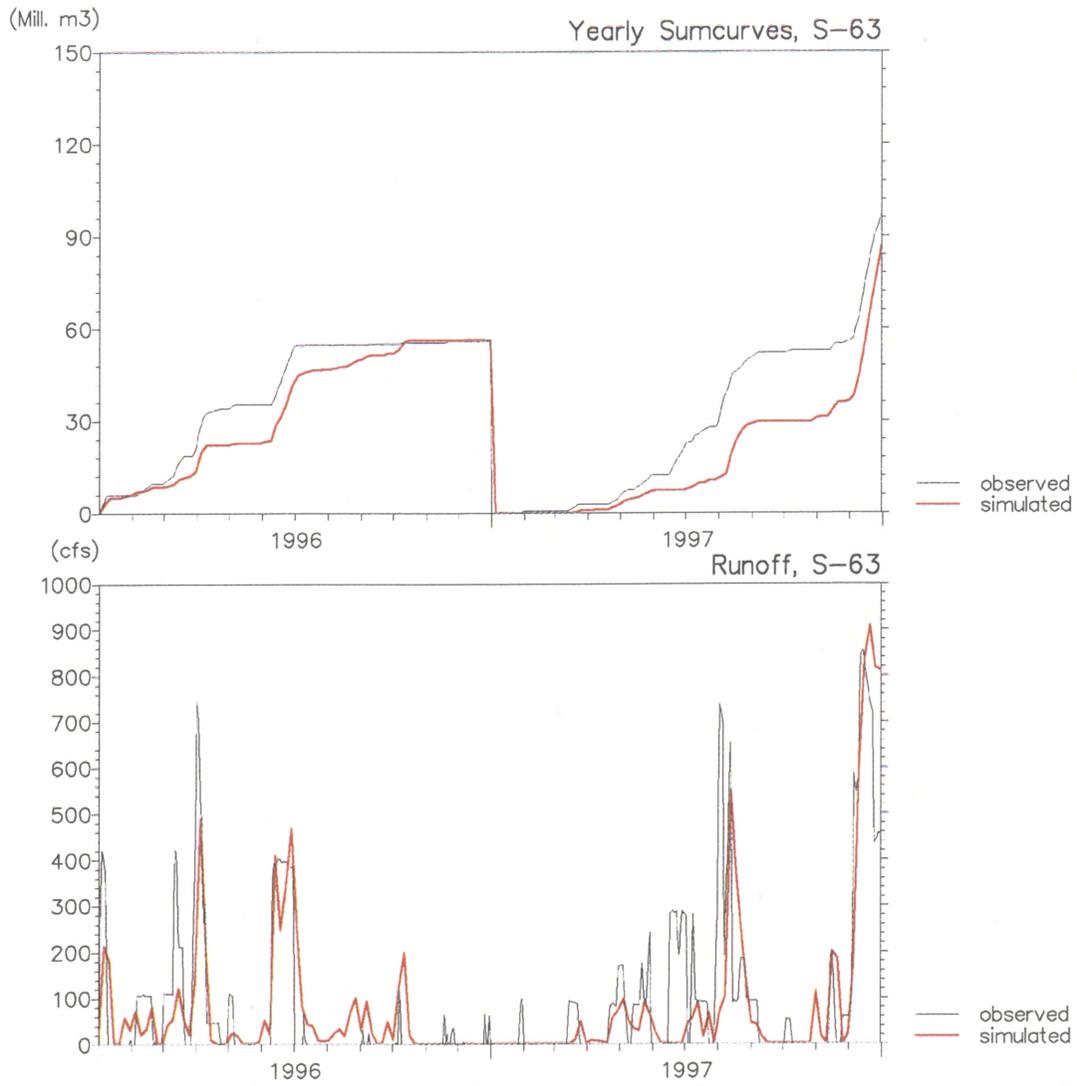
Figure 4-20 Observed and Simulated Runoff at S-63, Model Validation.
